SUBAQUEOUS CAST IRON POTABLE WATER MAIN JOINT REPAIR.....JANUARY 2014

LOGAN DIVING & SALVAGE COMPLETES UNDERWATER CAST IRON POTABLE WATER MAIN BALL AND SOCKET JOINT REPAIR.

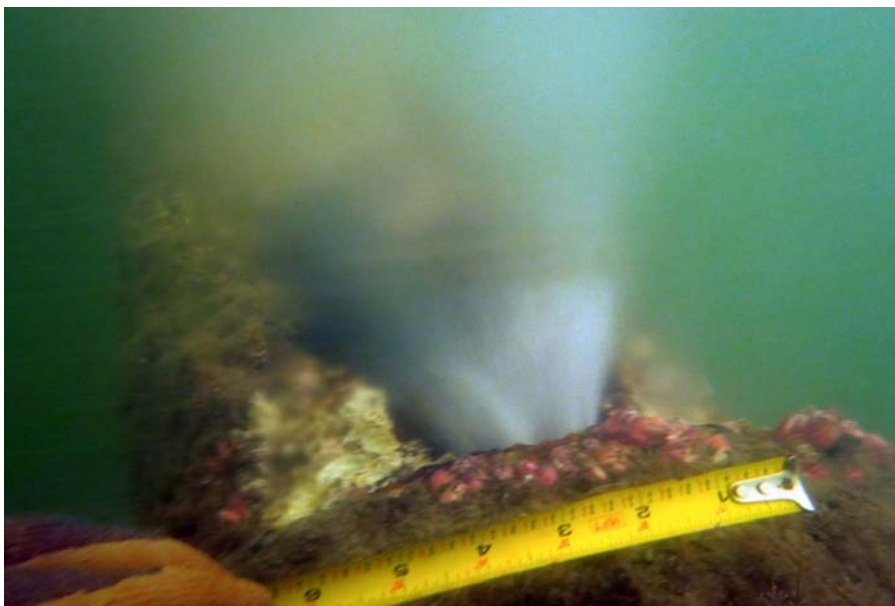
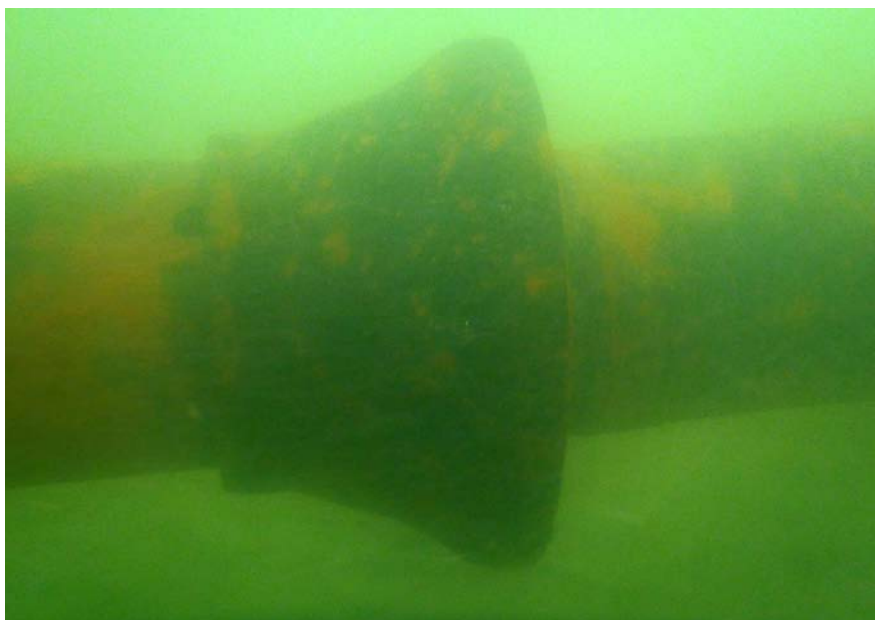
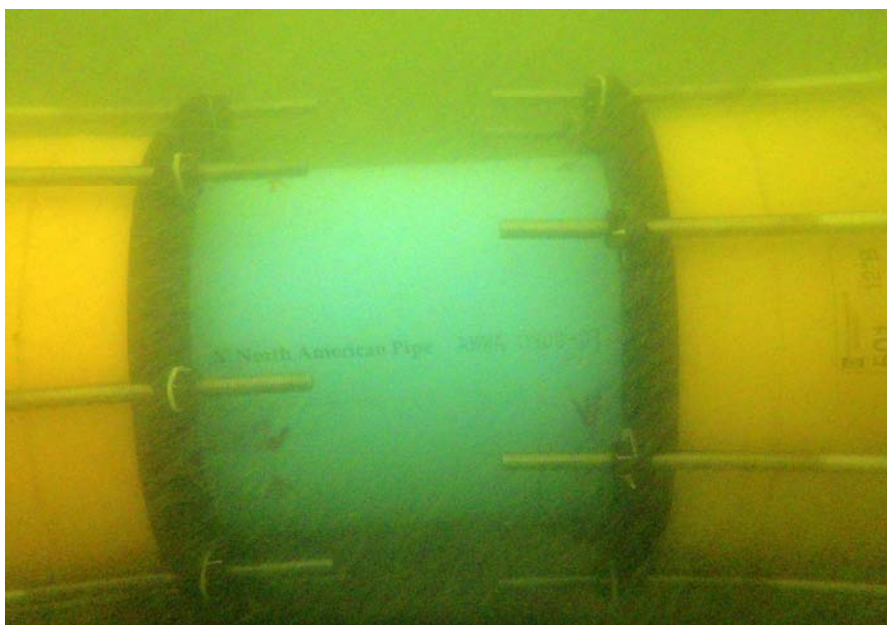
DIVE TEAMS MOBILIZED TO THE SITE AND FIRST LOCATED THE FAILURE AT A BALL AND SOCKET JOINT. THE PIPELINE WAS FOUND SUSPENDED AND WAS SUPPORTED PRIOR TO SECTIONING. SECTIONING WAS COMPLETED BY CUTTING OUT THE FAILED JOINT OF THE CAST IRON PIPE FOR SPOOL PIECE INSTALLATION. CLAMPS WERE SPECIFIED AND ORDERED FOR DIFFERING OUTSIDE DIAMETERS AND WERE EPOXY COATED POST FABRICATION.

CLAMPS AND SPOOL PIECE WERE INSTALLED, TORQUED, PRESSURE TESTED, AND PASSED 100%.

WITH NO LEAKS NOTED, SUPER CHLORINATION WAS INITIATED AND THE LINE BROUGHT BACK INTO SERVICE 1 WEEK AFTER INITIAL DISCOVERY OF THE FAILURE. SAFETY FIRST!!!!
