## Dramatic Underwater Repair in Indian River Keeps Florida City Gas Customers Online

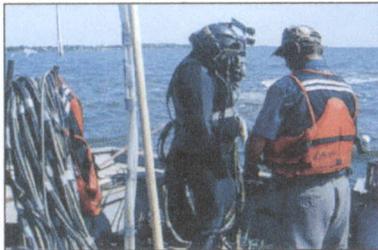
Logan Divers handled the underwater duties.

Using vacuums to suck up the sandy sediment, divers spent two days excavating a 30-foot-long by 6-foot-deep by 2-foot-wide hole around the leaking pipe. The sediments were "jetted" on to the side underwater to be replaced later. Three divers rotated in shifts of four hours underwater throughout the five days of the project.

The divers removed the pipe's cement coating (without the concrete, the gas-filled line would float) and cleaned the area to find the clamp and the 2-inch "blow-down," which is a valve, facing downwards instead of up.

The pressure in the 60-pound line was lowered and equalized at 15 pounds, which was maintained so water would not enter the line. To install the **Syntho-Glass**, the divers mixed a two-part Kevlar-reinforced epoxy and applied it to the pipe in preparation for winding the woven **Syntho-Glass** around the pipe. Just 30 minutes after they began the process, winds on the surface kicked up to 30 mph, stirring up silt below and decreasing visibility.

But the AGL Resources team persevered. The epoxy application took two hours, then the divers began to wrap. Over two days, the divers applied a total of 28 rolls of 4-, 6- and 8-inch-wide **Syntho-Glass** to build a "composite sleeve" around the leaking pipe. The AGL Resources team monitored the 15-pound pressure in the pipe overnight, until the process was complete.
